# Commercial and Industrial Rehabilitation Guidelines

Following are rehabilitation guidelines specific to Newnan's commercial and industrial buildings. These guidelines provide guidance to property owners in making sound decisions when planning and carrying out a rehabilitation project as well as providing technical information regarding historic materials and appropriate rehabilitation methods.

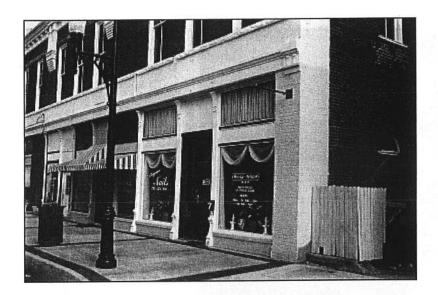
The storefronts in this building retain their original arrangements including cast-iron columns, display windows, transoms, and entrances.

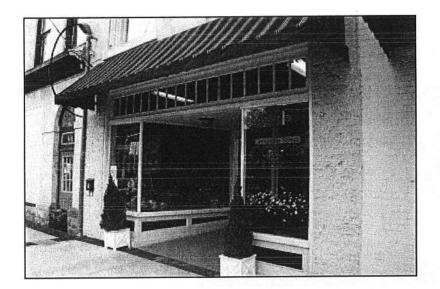
This storefront retains its recessed entrance, large display windows, woodpaneled bulkheads, and multi-pane transom.

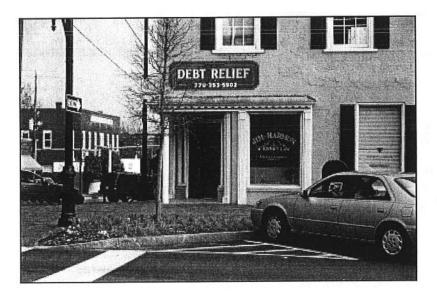
This corner storefront retains its distinctive angled entrance and corner support column as well as its display windows.

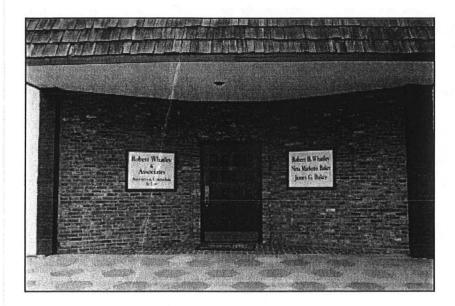
This building's originally open glass storefront has been completely infilled with solid materials.

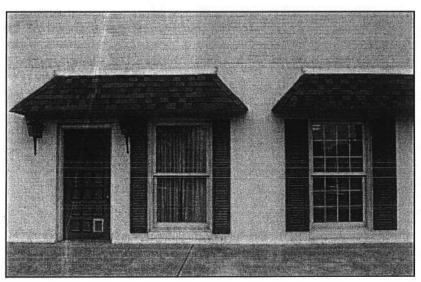
This street-level storefront space has been infilled with solid wall materials punctuated only by single windows and doors.

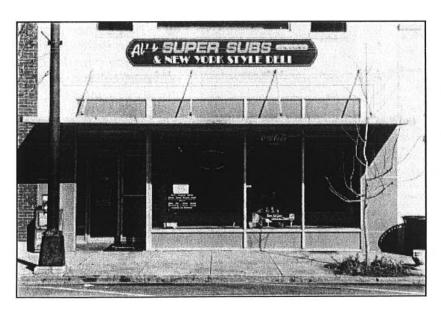
X This storefront has been covered with inappropriate materials.

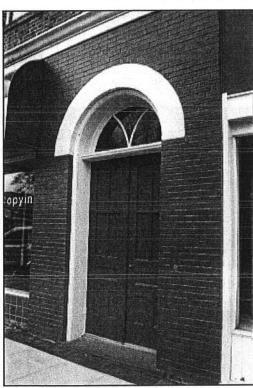
This entrance retains its arched transom, wood door frame, and double wood doors.

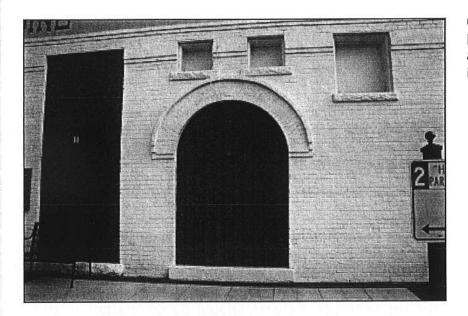
Although it may no longer be used, this arched entrance retains its original wood door.

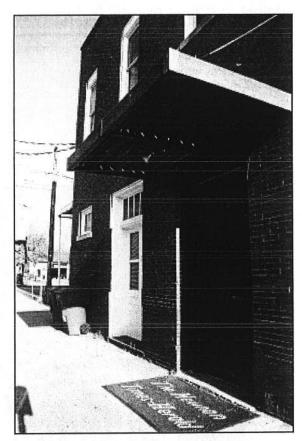
The entrance on the left retains its original door and transom; the entrance on the right has been replaced with an inappropriate anodized aluminum door, frame, and transom.

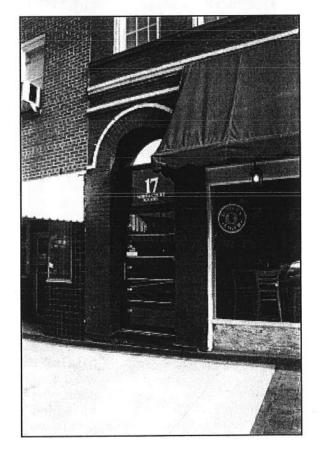
This arched entranceway remains intact but its door and transom have been replaced.

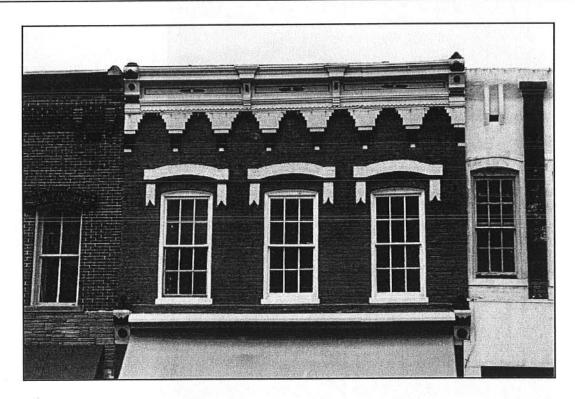
✓ This intact upper facade retains its decorative cornice, window hoods, and double-hung wood windows.

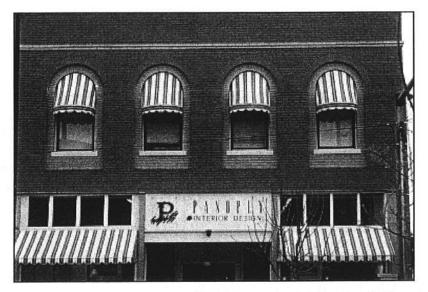
This upper facade retains its distinctive roundarched windows.

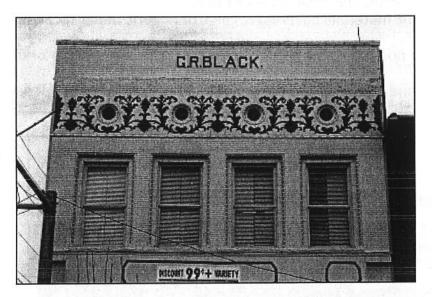
This upper facade retains its double-hung windows and distinctive details but has lost its cornice.

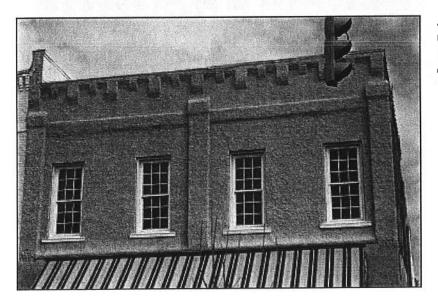
This historically brick upper facade and its details have been inappropriately covered with stucco.

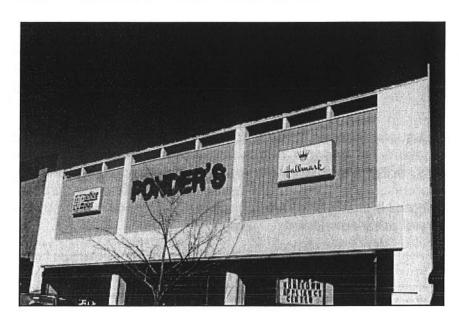
This upper facade has been completely covered with inappropriate materials.

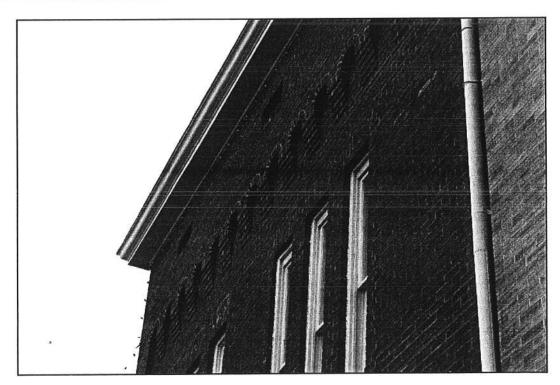
√ The brick corbelling on this upper facade is a distinctive detail that should be retained.

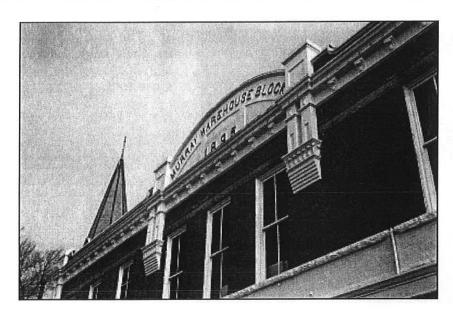
This very decorative cornice is a significant character-defining feature of the 1895 Murray Warehouse Block.

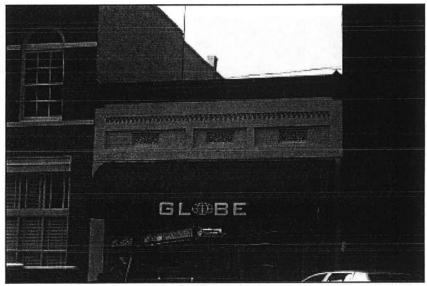
The decorative grilles, brick detailing, and pressed metal cornice are important details on this commercial building.

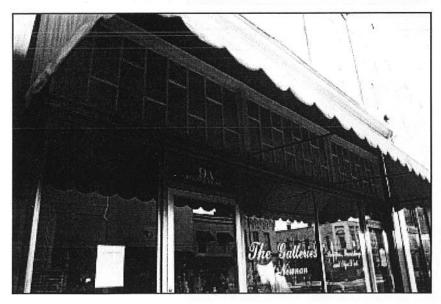
The distinctive transom is an important feature of this storefront.

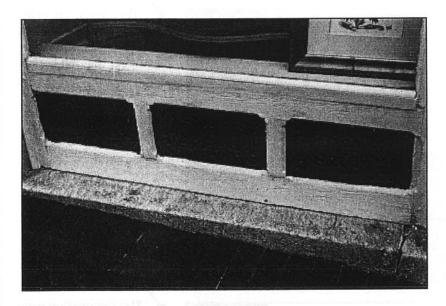
The cast-iron grilles in this bulkhead are significant details of this storefront.

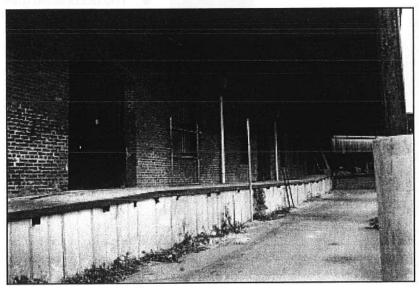
Wide, arched openings and loading docks are distinctive features of industrial buildings that should be retained.

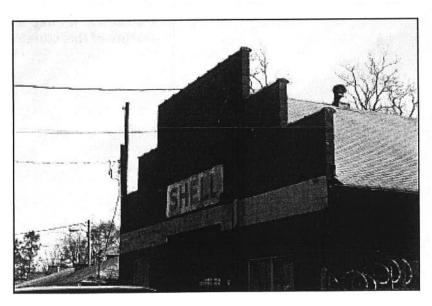
Stepped parapet walls are also distinctive features of industrial buildings.

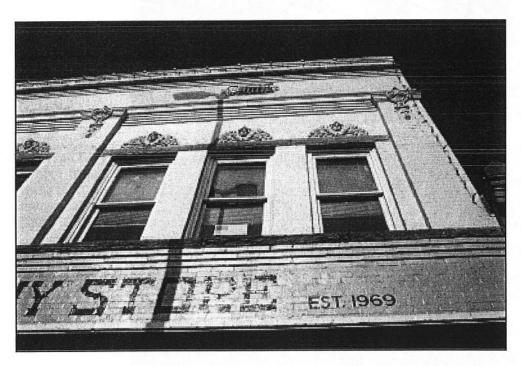
✓ The wood, double-hung windows in this building's second floor remain intact and provide light into the interior.

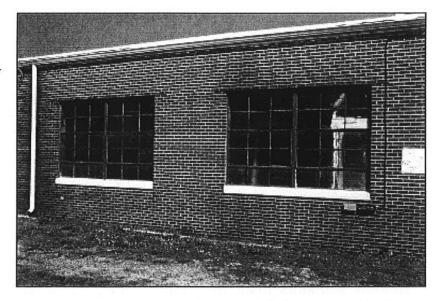
Industrial buildings generally have metalsash, multi-paned windows with one section that opens inward.

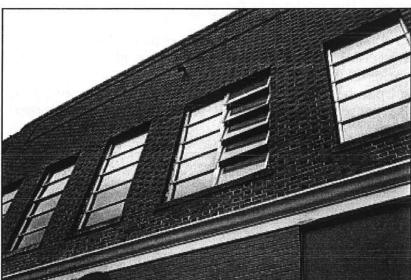
X This building's original windows have been replaced with inappropriate metal-frame jalousie windows.

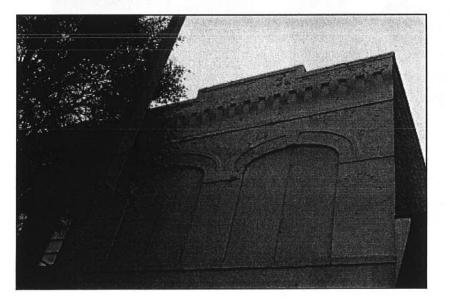
The windows of this upper facade have been completely covered; historic windows may remain intact behind the plywood.

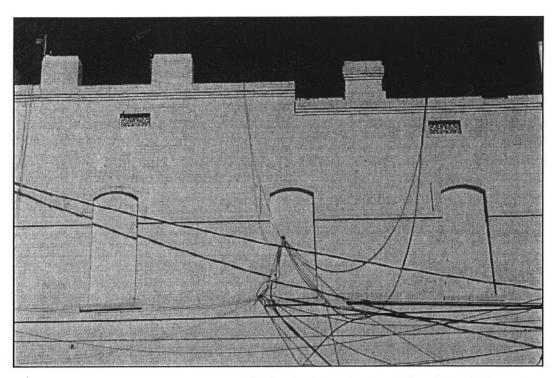
$m{X}$  Windows on side facades are also important features of a commercial building, particularly when the side facade is on a prominent corner; these windows have unfortunately been covered.

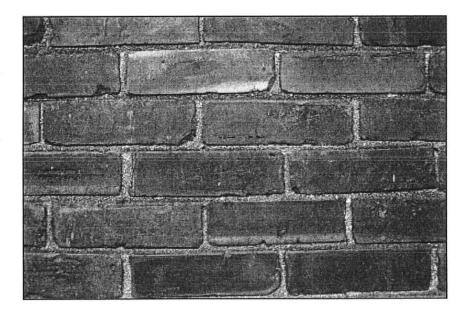
Brick is the most common exterior material for historic commercial buildings; various colors and sizes of brick dating from different periods can be found in many commercial areas.

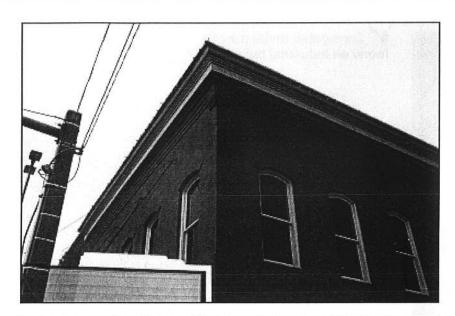
Stucco is sometimes used as an exterior finish material.

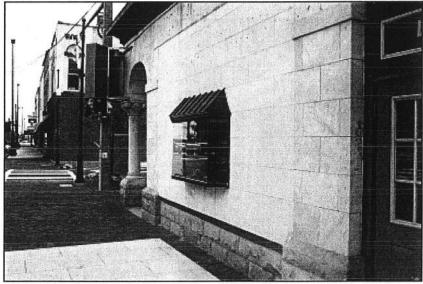
Stone, including granite and marble, was often used as an exterior finish material for banks.

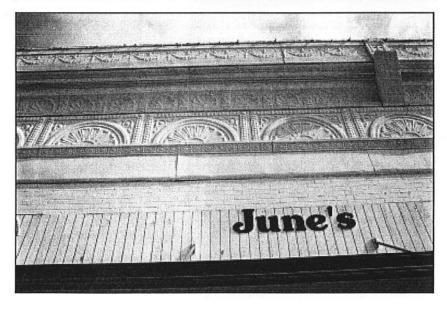
Pressed metal was often used for decorative cornices.

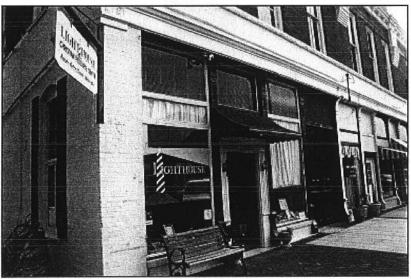
Cast-iron columns are used to support the weight of upper floors.

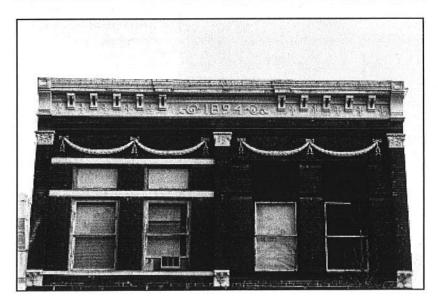
Materials such as terra cotta were used for decorative details.

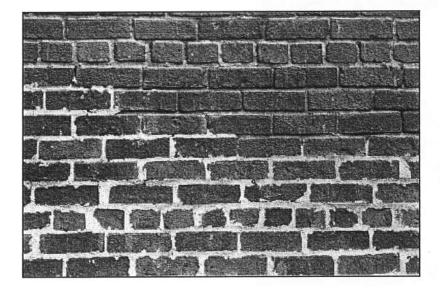
This brick masonry has been poorly repointed.

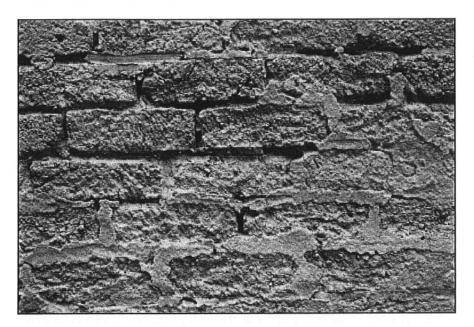
This brick wall has been sandblasted, removing the hard outer coating of the bricks; in an effort to stop deterioration, the wall has also been painted.

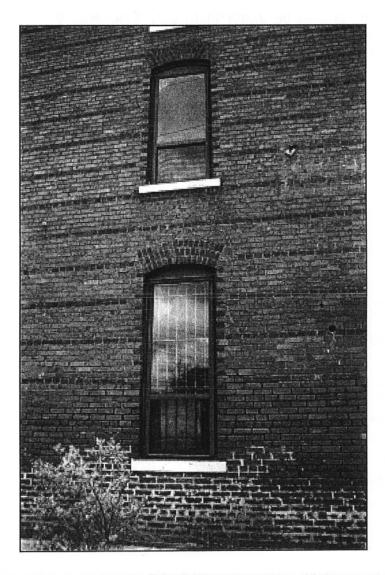
The upper portions of this brick masonry appear to be in good condition; however, the lower portions have lost mortar and have been poorly repointed.

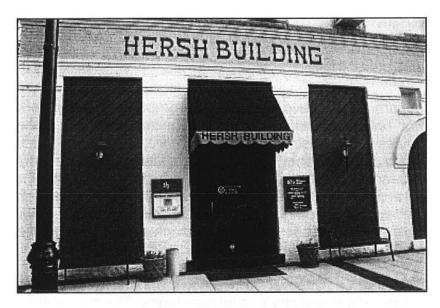
Awnings are an appropriate place for signs.

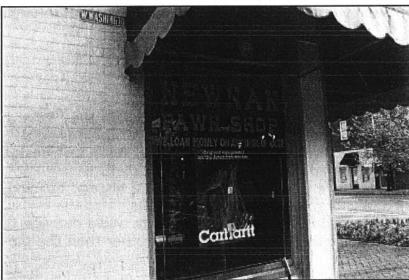
Creative signage may also be painted on display windows.

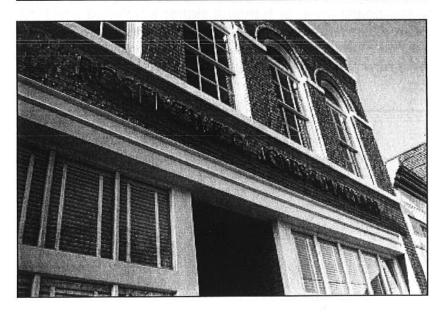
Signs may be placed in the rectangular sign space directly above the storefront in most commercial buildings.

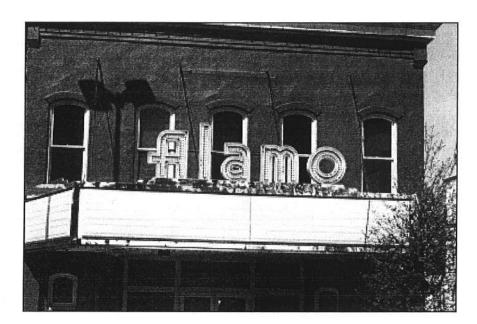
Historic signs that have a significant community association should be retained.

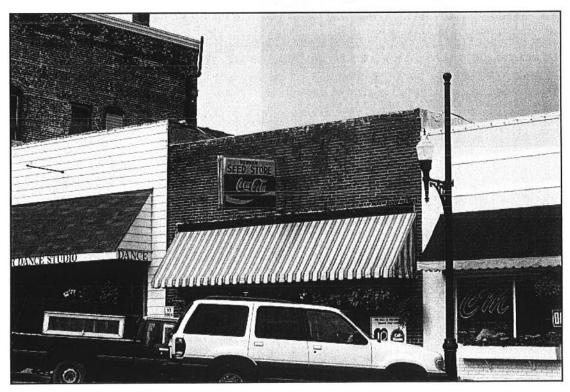
✓ Canvas awnings are the most appropriate awnings for historic commercial buildings.

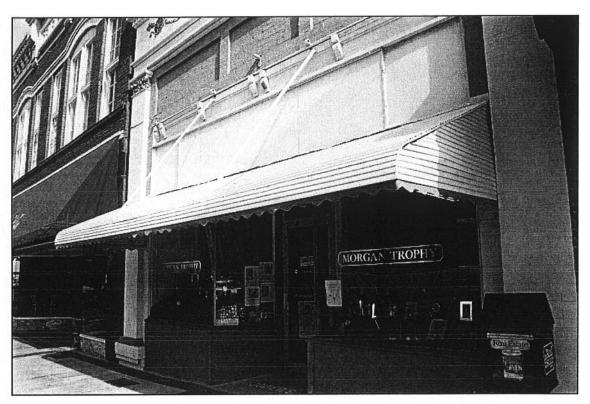
✓ Some metal awnings are now becoming historic.

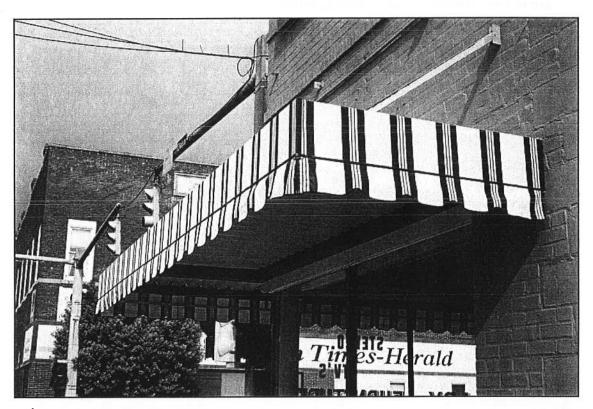
✓ A canvas "skirt" may be used to cover a nonhistoric flat metal awning.

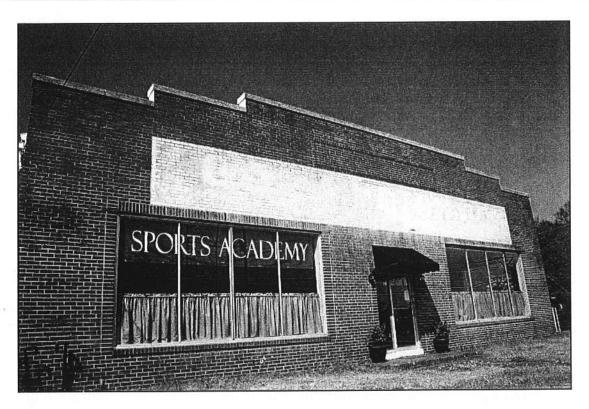
✓ Many industrial buildings have slightly pitched roofs and stepped parapet walls.

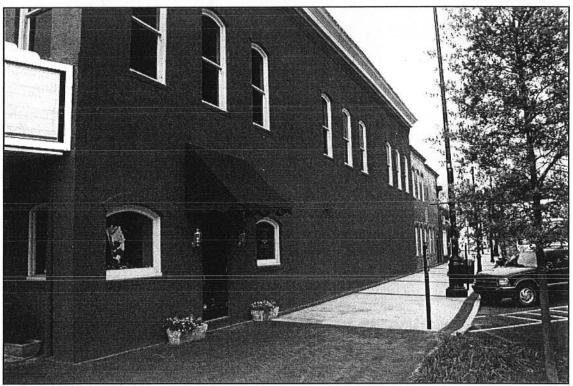
✓ Side facades, particularly on corner buildings, should be as well-maintained as front facades.

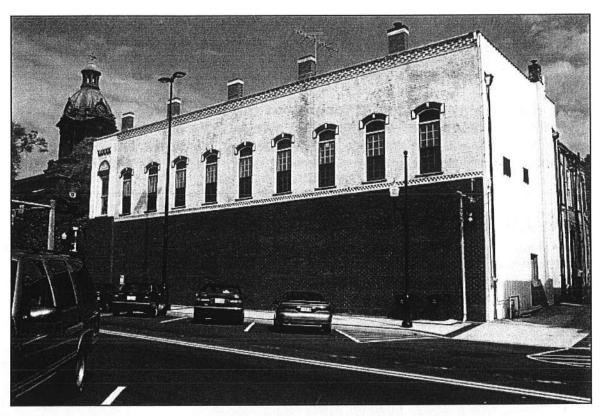
X This side facade has unfortunately lost its first-floor entrances and openings.

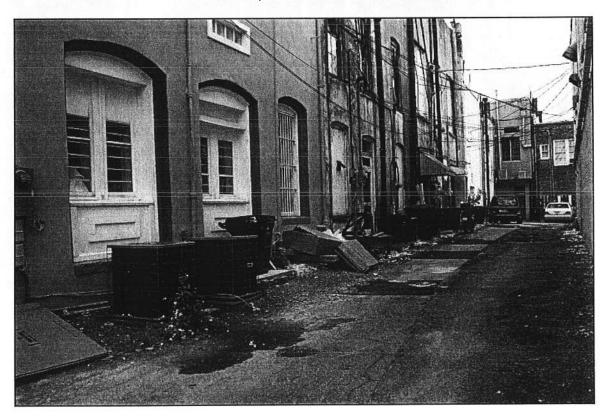
$m{X}$  These rear entrances could be made much more attractive and usable if they were properly maintained.

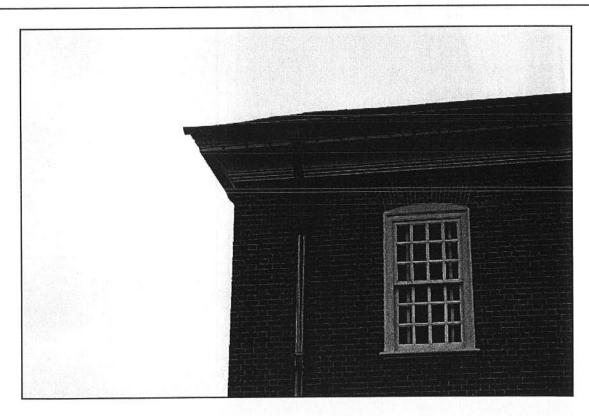
✔ This gutter and downspout system is well-maintained.

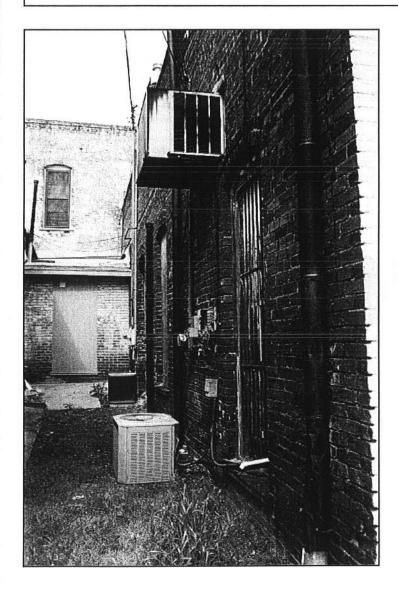
This mechanical equipment is appropriately placed at the rear of these commercial buildings.

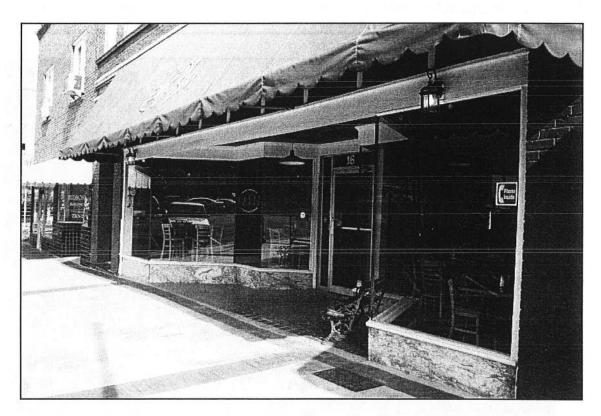
✓ This storefront is probably not original to the building but was added at a later date and has gained significance in its own right.

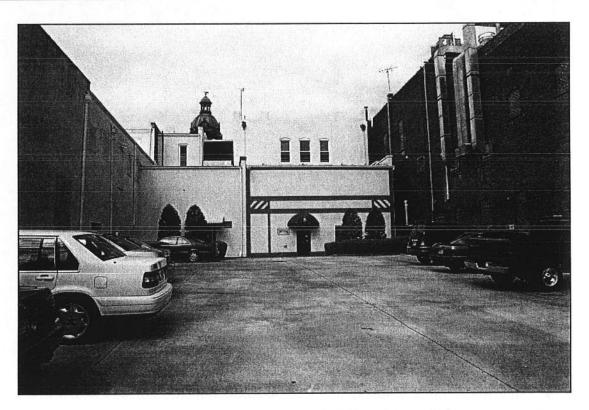
✓ These additions have been appropriately placed at the rear of these commercial buildings.
