Urban Image

SECTION 14 – URBAN IMAGE

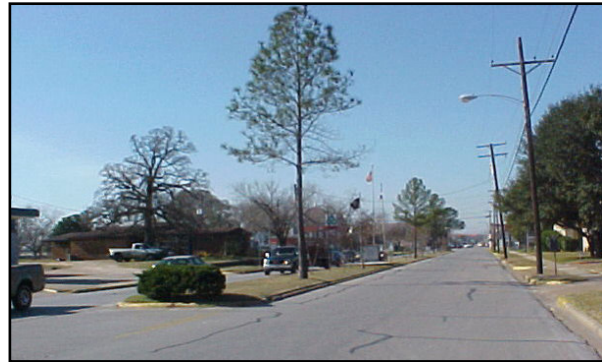
Landscape Median on East Washington Avenue

In addition to the primary gateways, Downtown gateways were also identified. Generally, citizens who were surveyed liked the “boulevard” feel of East Washington Avenue, with its landscaped medians and the LaSalle statue serving as a gateway marker (Map 14.2).

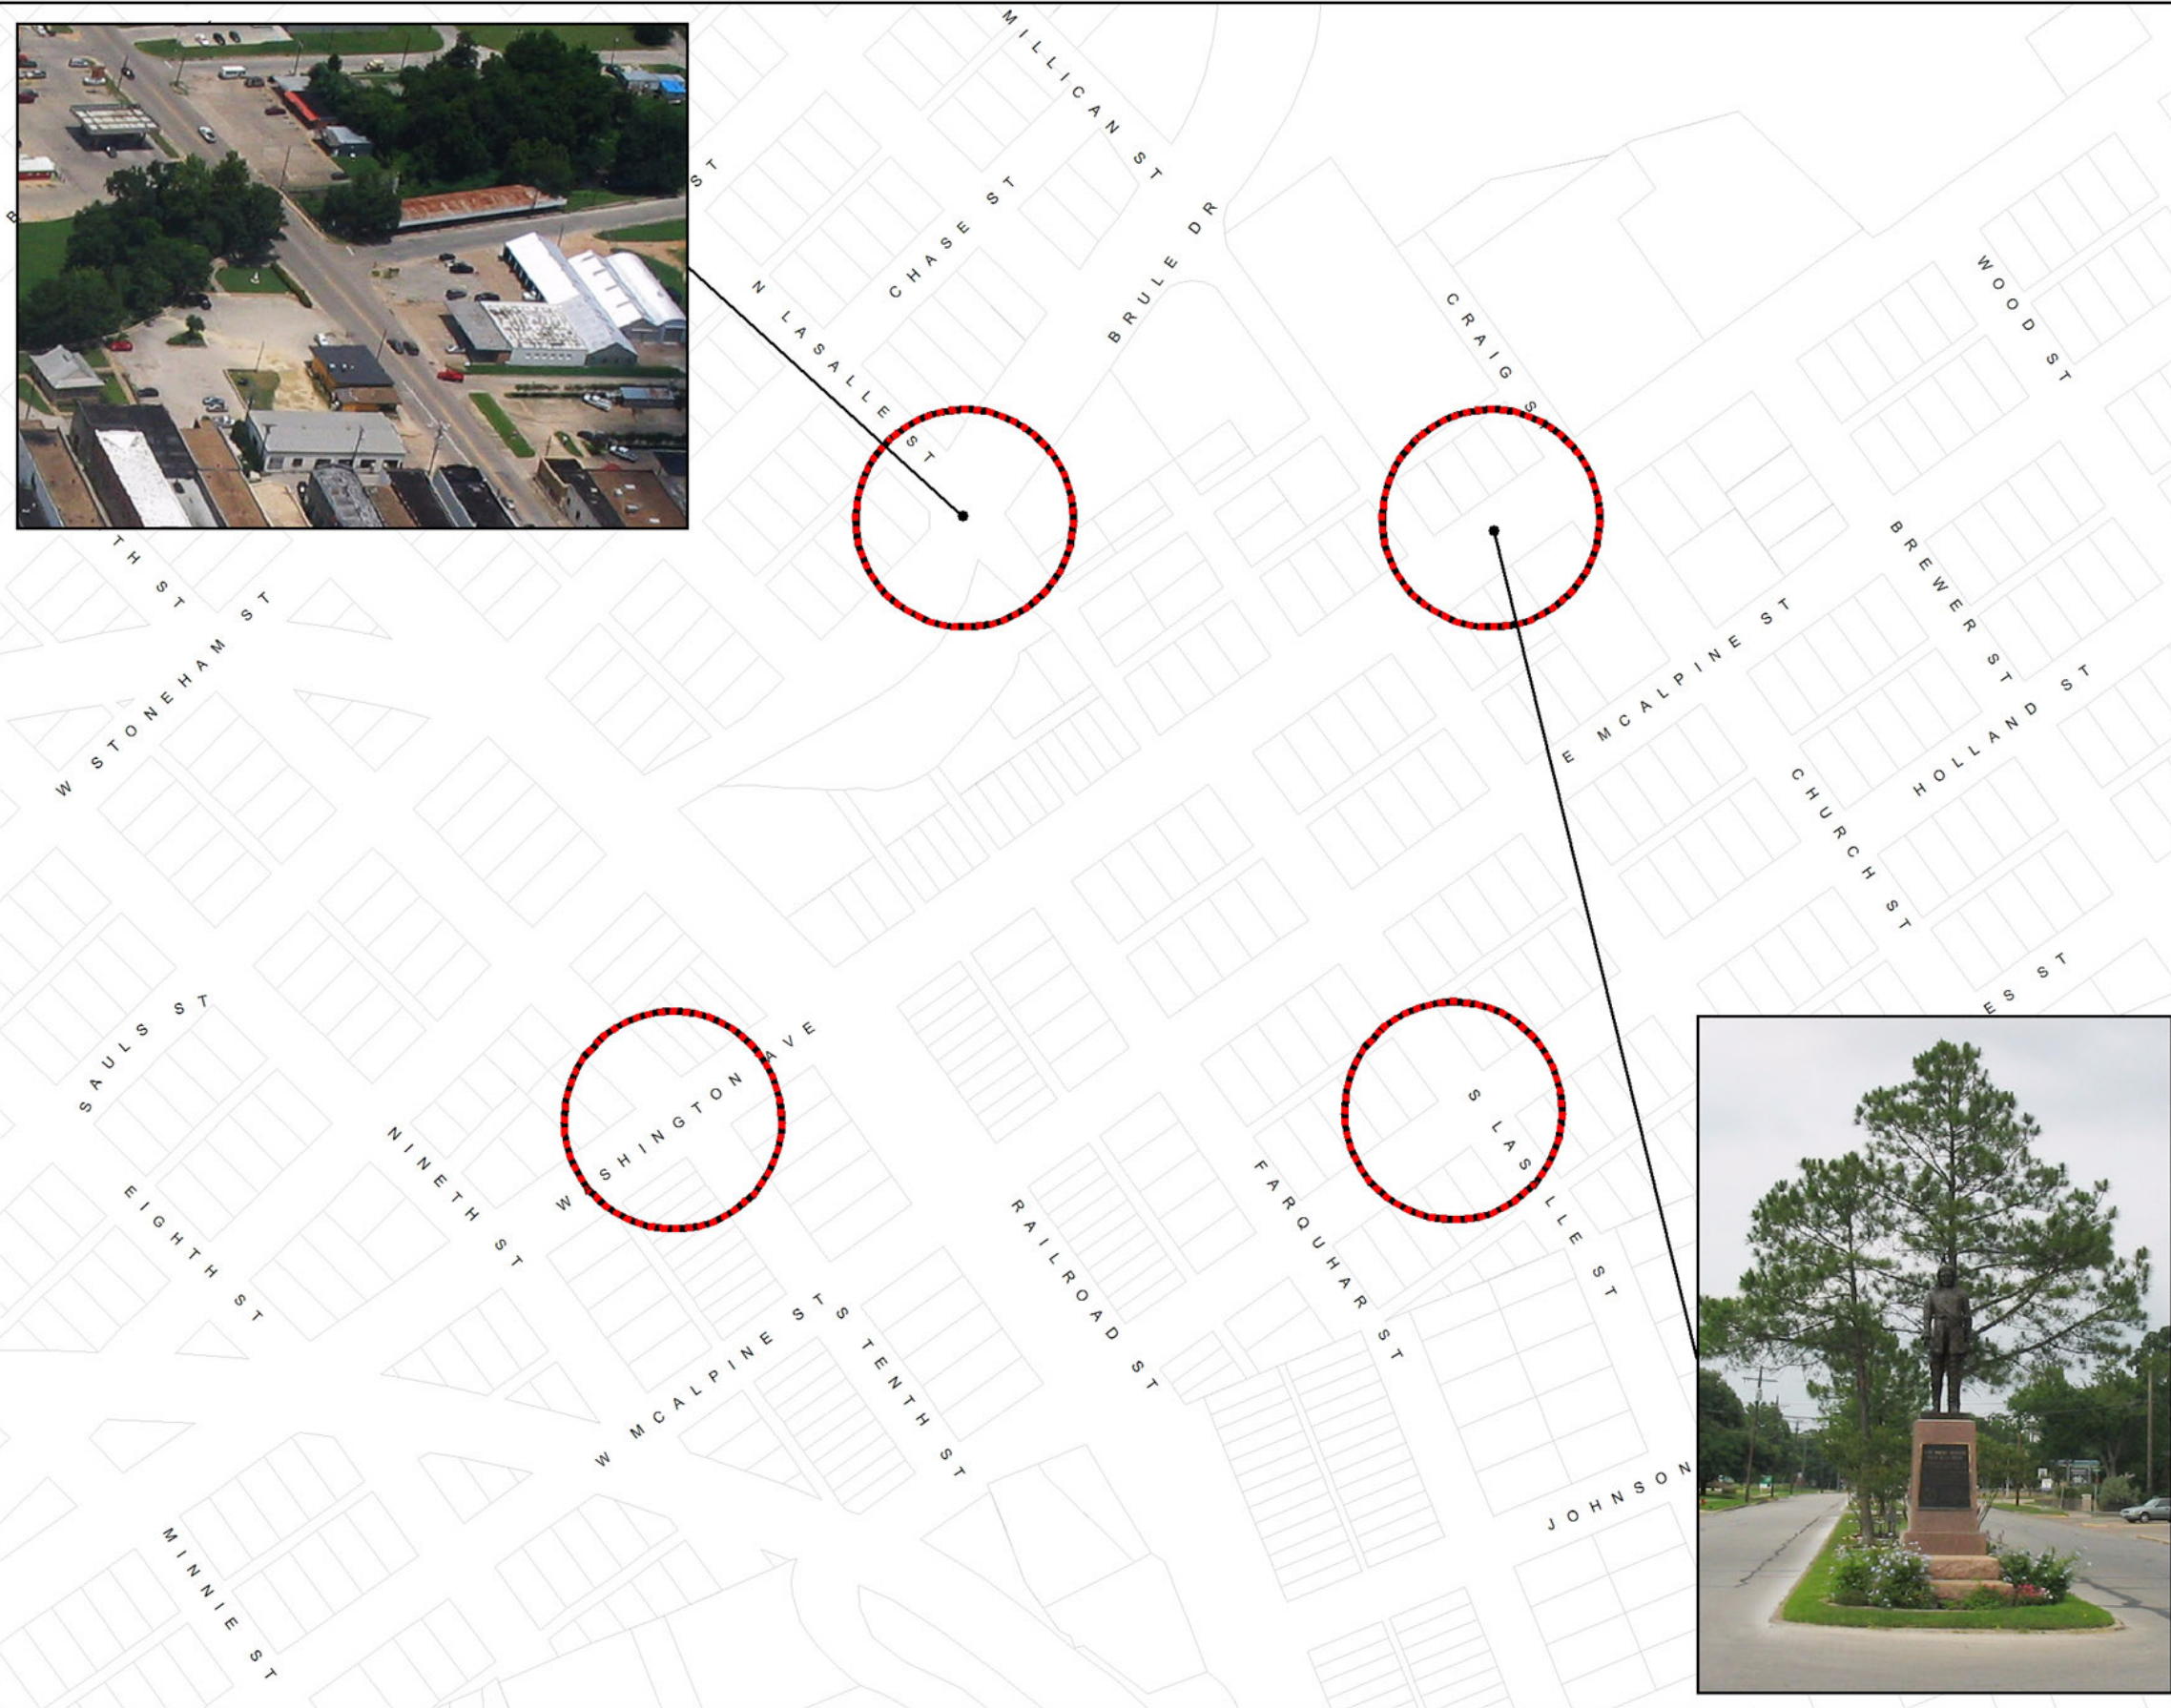
Map 14.2:
Downtown Gateways

1. The intersection of LaSalle Street and Church Street.
2. The intersection of Washington Avenue and 10th Street.
3. The intersection of LaSalle Street and Holland Street.
4. The intersection of LaSalle Street and Brule Drive.

Citizens expressed a dislike for the western gateway along Washington Avenue. One citizen in particular noted the need for an additional statue to mark the western entrance into Downtown. Citizens also offered criticism regarding the north-south gateways along LaSalle Street. Currently, there are many automotive uses and open automobile storage facilities along LaSalle Street. Citizens also expressed an interest in establishing stricter design standards and sign controls.

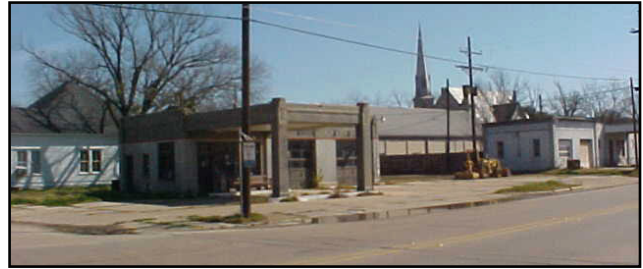
Underutilized Structures in Navasota

Overall, Navasota's urban fabric is in relatively good condition, though some structures are currently underutilized. Storage remains the primary use for the upper stories in most buildings in the Downtown. Opportunities exist for the establishment of loft living in the upper stories of buildings, allowing for a more dynamic mix of land uses along Washington Avenue. Navasota's historic commercial buildings are the downtown area's most marketable assets. Vacant buildings and open storage of vehicles and machinery are the primary sources of blight confronting travelers driving through Navasota. On the positive side, trash receptacles have been placed throughout the Downtown, resulting in a largely litter free environment along Washington Avenue, LaSalle Street, and Farquar Street.

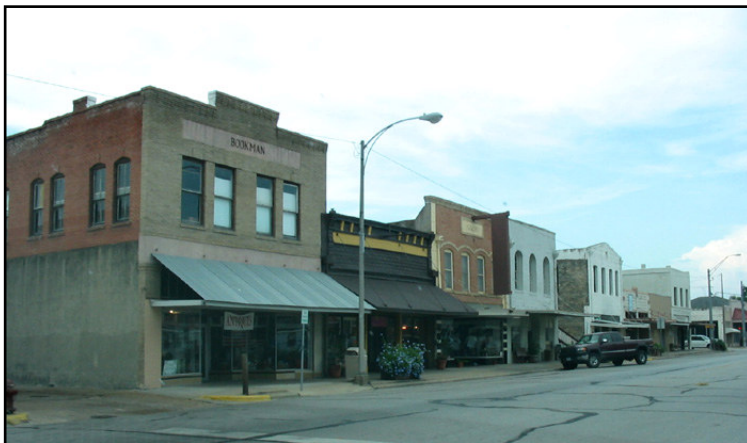
Navasota Streetscape

Streetscape may be defined as the visual experience resulting from the combination of elements such as streets and sidewalks, lighting, street furniture, landscaping, and signage. The streetscape is one of the most visible reflections of the vitality of an area. The Downtown streetscape consists

of façades, walkways, street furniture, utility lines, and planters. Each of these elements has an impact on pedestrians and their sense of place within Downtown. Existing walkways provide pedestrians with access to local shops and businesses. Access across intersections, however, can be difficult at times due to the length pedestrians must travel, as well as American Disabilities Act accessibility issues.

Trash receptacles and benches are adequate in number, but could incorporate historic themes to better complement the area. The existing planters in the area are adequate, but an infusion of additional plant material would significantly improve the overall look of the Downtown. The impact of overhead utility lines is minimal throughout Downtown.

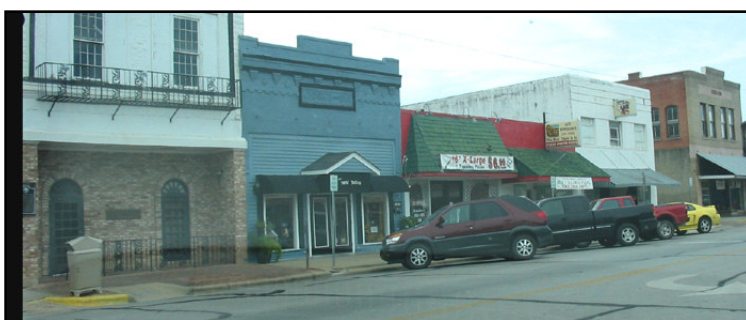
On Street Parking in Navasota

Some citizens were also concerned about the diagonal on-street parking along Washington Avenue. Washington Avenue is a four lane highway with a center turn lane and on-street parking. The process of backing out of these diagonal parking spaces conflicts with moving traffic, and creates congestion along Washington Avenue. However this activity also serves as an excellent traffic-calming device, ensuring slower speeds and a more comfortable pedestrian life.

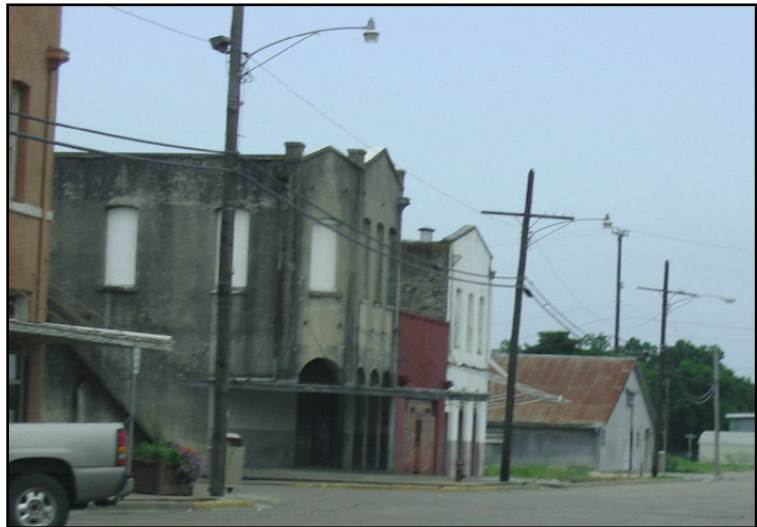
Vacant Structure in Navasota

In addition to Navasota's vacant commercial structures, other underutilized resources in the City include vacant buildings and underutilized tracts of land. Unimproved property provides opportunities for infill projects. In the public participation meetings, citizens identified the need for more parks and green space in Downtown, extending beyond the railroad tracks into western Downtown Navasota. Citizens also expressed the need provide better connections to the hike/bike trail along Cedar Creek.
